Manhole Inspection Summary

Manhole # S31Q1_014MH

Insp Date: **2/4/08 2:09 PM**

Location Address: **3218 Cherryland Rd** Cross Street: **Deacon Hill Ct.**

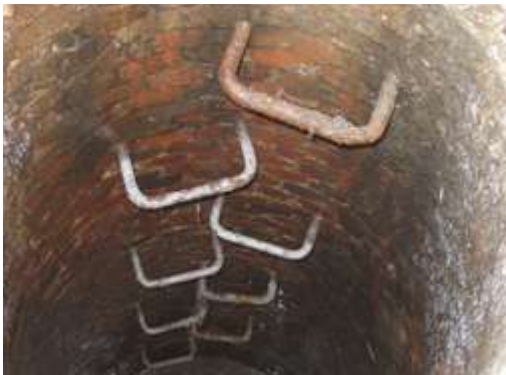
Steps Count: **8** Missing: **0** ☐ Corroded

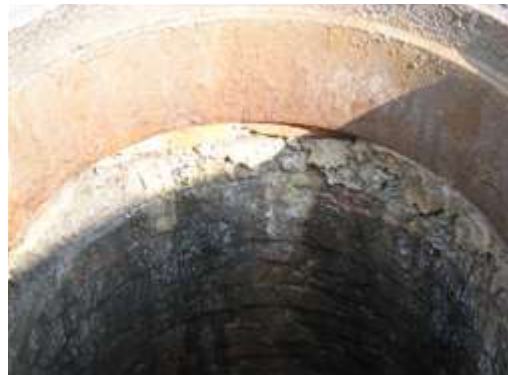
Defect 1

Chimney / Frame Adjustment ☒ Exists Material: **Brick** ☐ Parged Height: **4** (in.)
Condition: ☒ Sound ☐ Cracked ☐ Root Intrusion ☐ Loose Brick ☐ Deteriorated
Infiltration: ☐ None ☒ **Joint** ☐ Cracks ☒ **Mortar** ☐ Roots ☒ **Wall**

Chimney

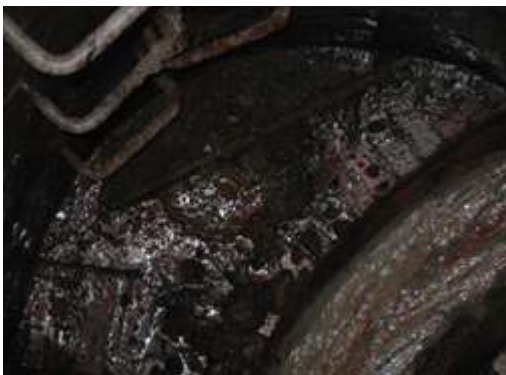
Defect 2

Bench ☒ Exists Material: **Brick** ☐ Parged
Condition: ☒ Sound ☐ Cracked ☐ Root Intrusion ☐ Deteriorated ☐ Leaks ☐ Debris

Bench

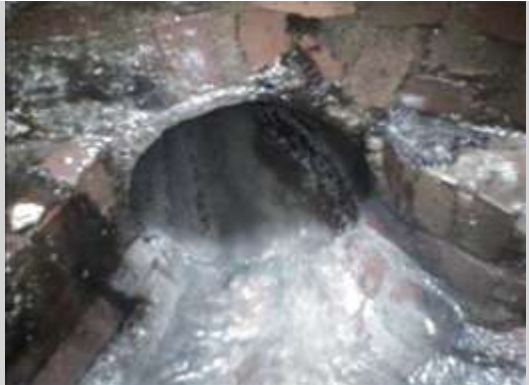
12 O'Clock Outflow

12 in. Circular Gravity Sewer
Pipe Out @ 12 O'Clock

Pipe Height: **13.2** (in.) Rod and Bar (Angled)
Pipe Material: **DIP/CI** ☐ Pipe Lined
Invert Depth: **13.95** (ft.) Flow Characteristics: **Fast**
Deposits: ☒ None ☐ Mud ☐ Sludge ☐ Debris ☐ Grease
Silt Depth: (in.) Deposits Extent:
Infiltration: **None** Pipe Seal Cond: **Sound**

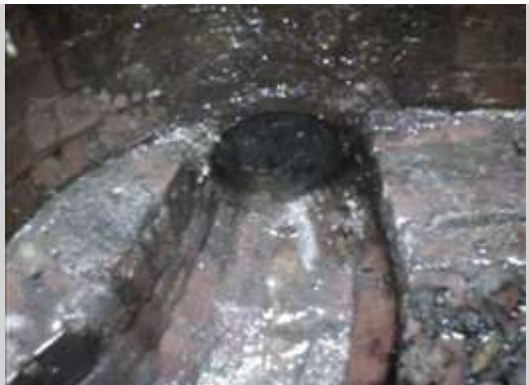
2 O'Clock Inflow

8 in. Circular Gravity Sewer
Pipe In @ 2 O'Clock

Pipe Height: **9.6** (in.) Rod and Bar (Angled)
Pipe Material: **DIP/CI** ☐ Pipe Lined
Invert Depth: **13.61** (ft.) Flow Characteristics: **None**
Deposits: ☒ None ☐ Mud ☐ Sludge ☐ Debris ☐ Grease
Silt Depth: (in.) Deposits Extent:
Infiltration: **None** Pipe Seal Cond: **Sound**

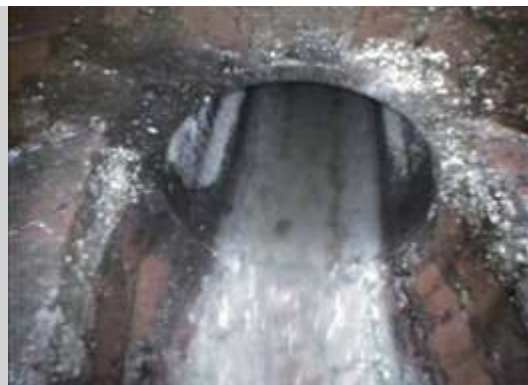
8 O'Clock Inflow

12 in. Circular Gravity Sewer
Pipe In @ 8 O'Clock

Pipe Height: **13.2** (in.) Rod and Bar (Angled)

Pipe Material: **DIP/CI** ☐ Pipe Lined

Invert Depth: **13.73** (ft.) Flow Characteristics: **Fast**

Deposits: ☒ None ☐ Mud ☐ Sludge ☐ Debris ☐ Grease

Infiltration: **None** Pipe Seal Cond: **Sound**
